VETERINARY REPORT

HORSE: XXXXXXXX

DATE OF EXAMINATION: 27TH JUL 23 PLACE: XXXXXXXX XXXXXXXXX

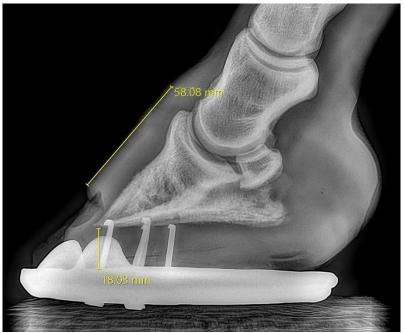
L FR 27^{TH} JUL 23

Dorsoventral radiographs **show incremental bone density** at the surgery site with formation of normal solar margin density and vascular channel formation (red arrows indicating change in bone density and redevelopment).

Lateral radiographs show 58mm from coronary band to surgical lesion. Post surgical measurements from coronary band indicate 32mm from coronary to wall surgical site indicating **26mm dorsal wall growth subsequent to surgery.**

POST SURGERY 27TH JUL 23

Post surgery the hoof has recovered well with significant dorsal wall growth: 26mm in 45 days, the equivalent of 17mm/30 days (average growth for thoroughbreds is 2.5 - 5mm/30 days)

The solar margin is indicating a return to normal trabecular structure. This **rarely occurs** and is a good prognostic indicator for full recovery.

The left front was trimmed and balanced, a steel heart bar applied with sole pack CS. The surgical site was debrided and additionally packed with sole pack CS.

The horse can now be turned out in a small yard without bandaging.

Continue Bone Gold at 3 x scoops once per day.
