### **VETERINARY POST SURGERY REPORT**

HORSE: XXXXXX

DATE OF EXAMINATION: 23RD MAR '22

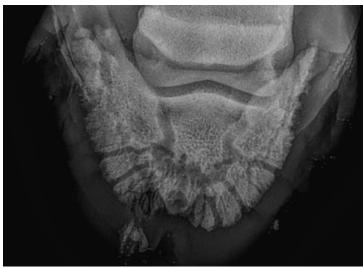
11<sup>™</sup> JAN 22 PRE-SURGERY

Of note, the horse has been sound since surgery and the surgical sites are clean and healthy. The curetted solar margin radiographically now shows a clearly defined margin on the dorsoventral and lateral views indicating no residual osteomyelitis.

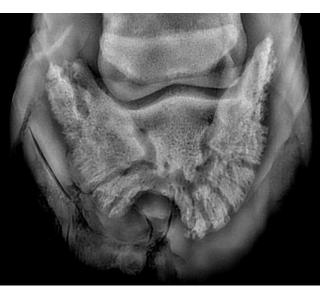
23<sup>RD</sup> MAR 22 POST SURGERY

Dorsal hoof wall growth rate 8 weeks post operatively is significant.

Dorsal wall measurements radiographically show unusually high growth rates with 38mm of hoof wall growth from the coronary band to the injury.

XXXXXX was shod all round on 23<sup>rd</sup> Mar with alloy plates with copper sulphate topically in solar and wall deficits with Sole Pack CS to seal surgical sites.

The left front lateral toe solar deficit was packed with copper sulphate and Sole Pack CS.

Initiate work on the walker with the object of progressing to the treadmill if hoof is stable and the horse remains sound.
